GRUNT/CREAK/CHIRP/SQUEAK NOISE FROM THE FRONT LOWER CONTROL ARM OVER BUMPS

TECHNICAL SERVICE BULLETIN

Reference Number(s): 13-9-3, Date of Issue: September 4, 2013

FORD: 2011-2014 Mustang

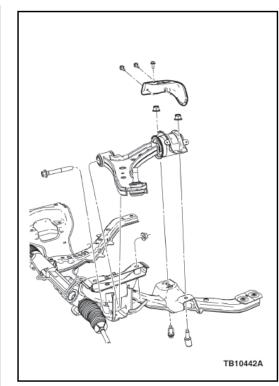
Figure 1 - Article 13-9-3

Some 2011-2014 Mustangs vehicles may exhibit a grunt/creak/chirp/squeak noise from the front lower control arm hydro bushing. These noises may occur over large vertical bumps like speed bumps, pot holes, rough roads and driveway approaches.

- 1. Attach Rotunda wireless chassis ears (JSP97202) or equivalent on both lower control arm hydro bushing bracket tabs to verify noise is coming from the hydro bushing.
 - a. The hydro bushing is the large diameter bushing at the rear of the control arm. Due to hydraulic fluid flow some noise from the bushing is normal. There would typically be some difference from side to side on a unit with a noisy control arm.
- 2. If the noise is not confirmed as coming from the hydro bushing, this article does not apply, refer to Workshop Manual (WSM), Section 204-00 for normal diagnostics.
- 3. If the noise is confirmed as coming from the hydro bushing, replace the affected lower control arm with the new lower control arm with shield and three (3) screws. Tighten the three (3) shield screws to 7 N.m (62 lb-in.) Refer to WSM, Section 204-01. (Figure 1)
