STEEDA S197 MUSTANG

Competition Upper Adjustable Trailing Arm/ 3 Link for S197 Mustang

555-4106, 555-4107, 555-4108, 555-4109 & 555-4111

Installation Instructions

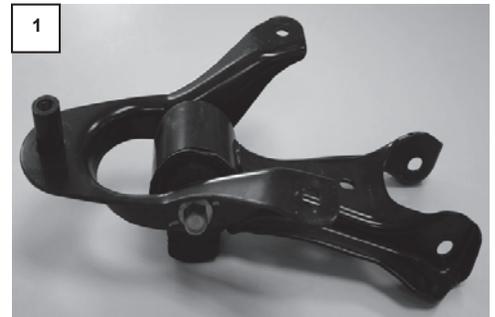
2. Remove the stock upper trailing arm assembly **Pic1**
 - a. Remove the bolt at the differential end of the control arm.
 - b. Remove the two bolts on the bottom side of the mounting bracket towards the rear of the vehicle.

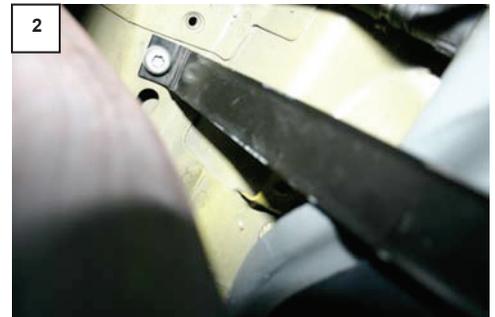
- c. Properly support the gas tank and remove the two rear bolts securing the tank straps **Pic 2**. Lower the tank approximately 2 inches to allow clearance to remove the OE bracket.

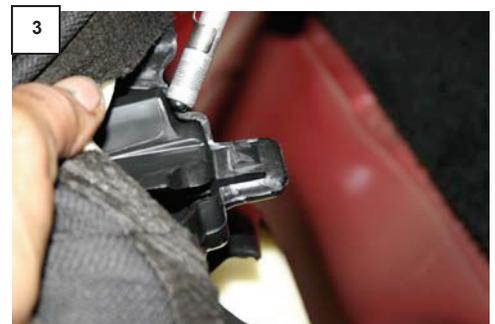
- d. From inside the car remove the front mounting bracket bolt **Pic 4** Note: It will be necessary to remove the lower half of the back seat to access the bolt. Remove the seat cushion by sliding your hand underneath the cushion and pushing the plastic release tab as shown in the picture **Pic 3**

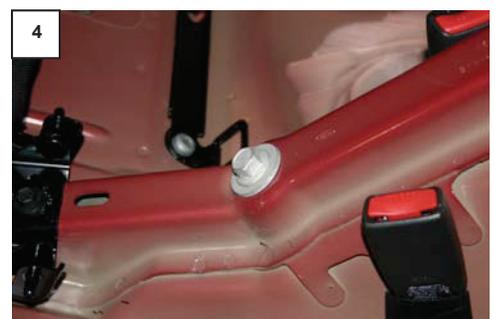
3. Assemble the new trailing arm to the new competition bracket. The rod end/bushing end should be bolted in the forward hole using the supplied nut, bolt and washer. Use the provided spacers to center the rod end between the bracket.
4. Before installing the new trailing arm you must adjust the length for a beginning setting. The factory upper trailing arm is approximately 215.4 mm (8.48") between the two mounting locations. For performance use we generally recommend you set the starting length at approximately 256.4 mm (10.21").
5. Install the new Steeda trailing arm assembly into the factory location. Note: It may be necessary to bend down the lip of the gas tank for clearance around the new bracket **Pic 5**
